Galena Sidewalk Assessment

2021

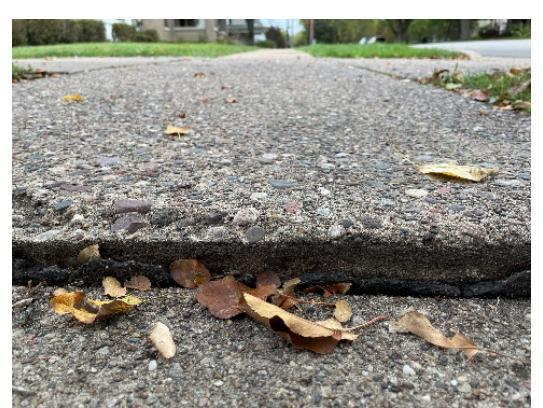
Vertical fault at 513 Park Ave

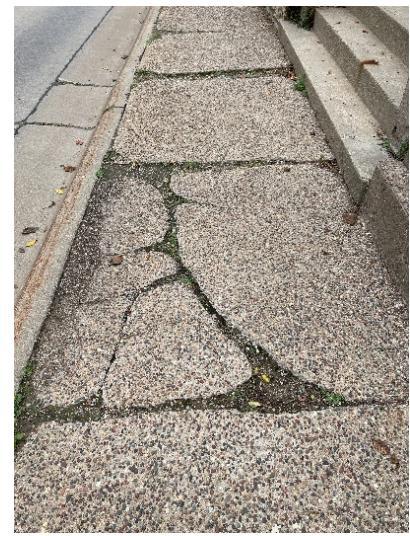
Cracking along S Bench St

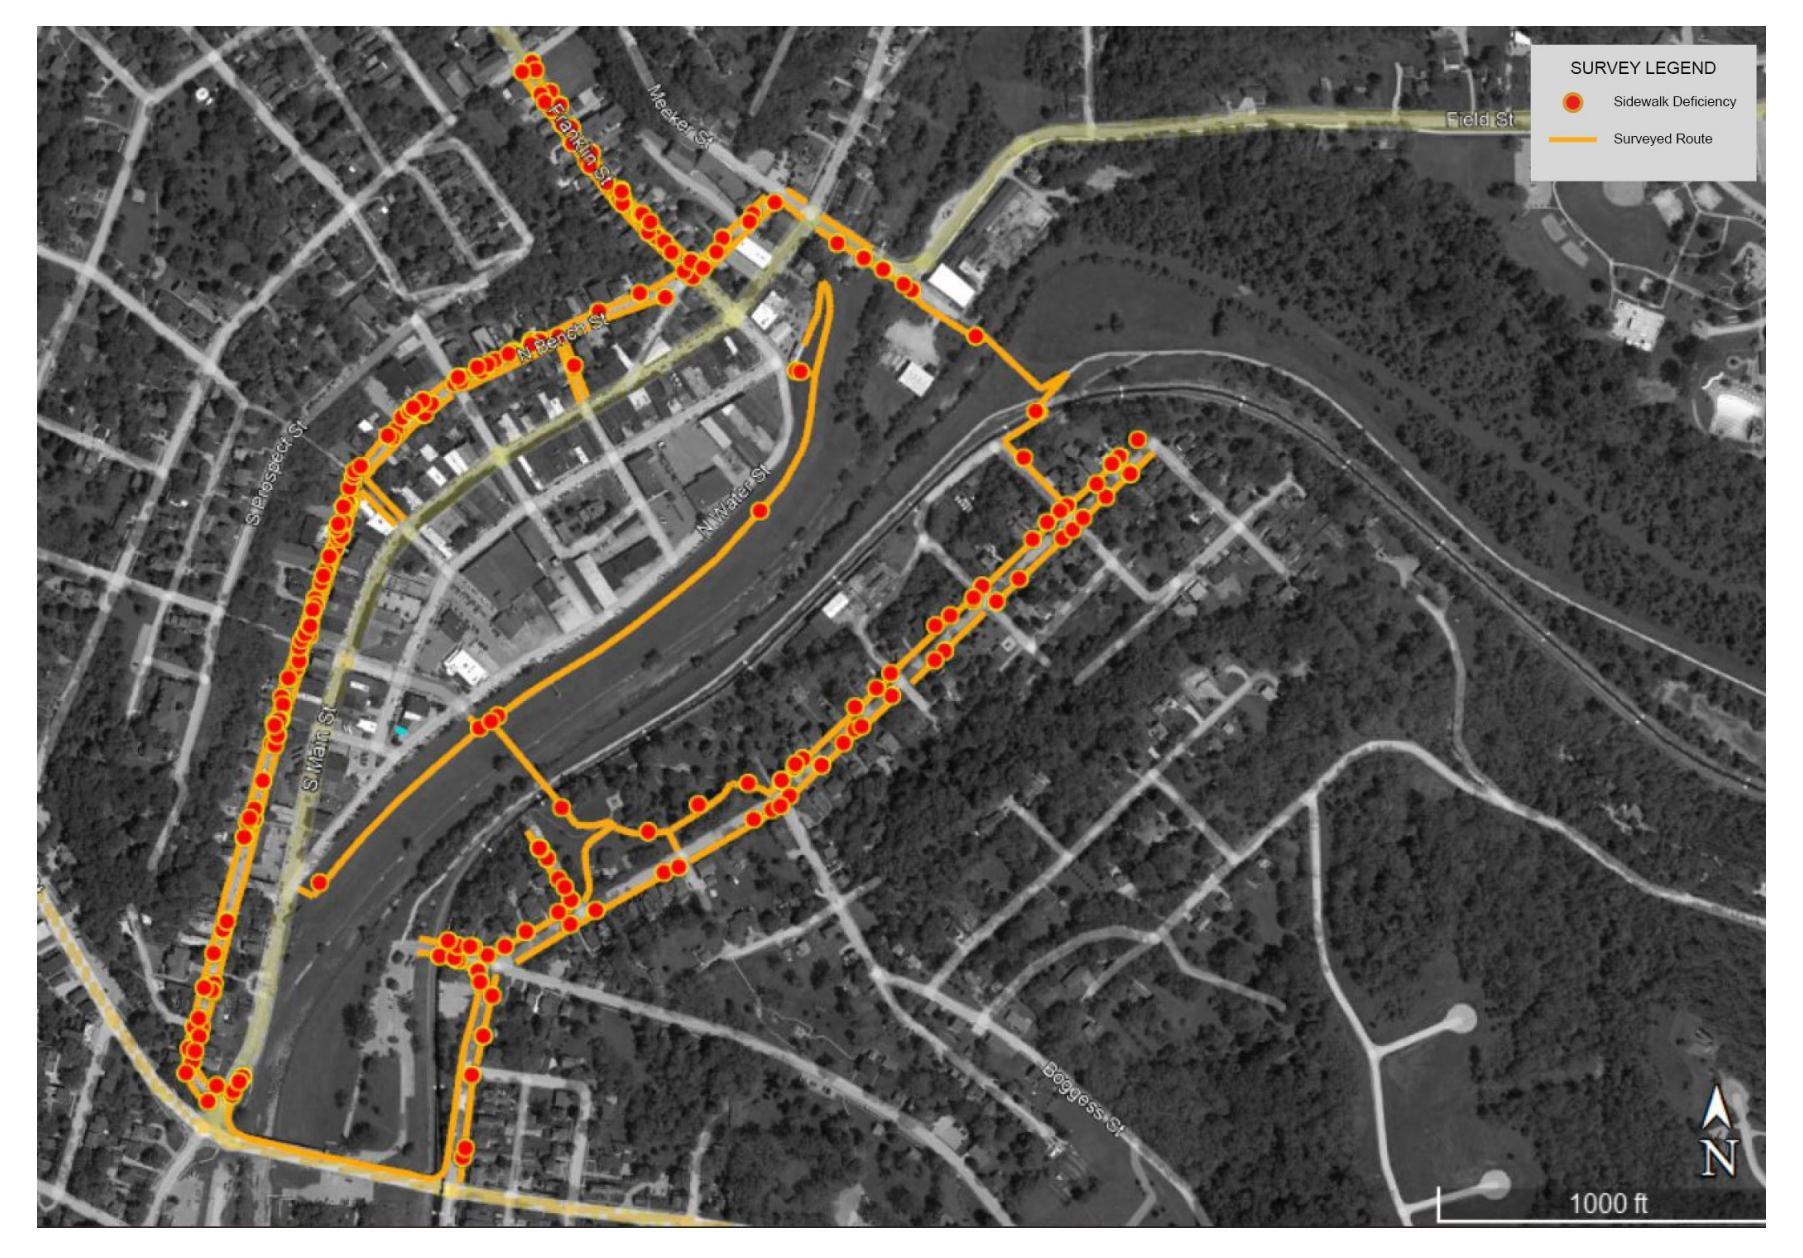
Appendix E. Galena Sidewalk Deficiency Points

An interactive map with the surveyed points and associated photos can be viewed through the <u>ArcGIS Survey123 Map Viewer</u>, and a static map showing the sidewalk deficiency points can be found in Appendix E. A shapefile of the georeferenced points with associated survey records is also provided along with this report for viewing in Google Earth.
